Re: Martin Dunham Reservoir Dam, DEC ID# 243-1430
Grafton (T), Rensselaer County
C Hazard – High Hazard Dam
Condition Rating: “Unsound – Deficiency Recognized”

Visual Observations

DAM NAME Martin Dunham Reservoir Dam
STATE ID 243-1430 *SECTION* C *HAZARD CODE* C
COUNTY Rensselaer *INSPECTION DATE* 1/5/2024
NEAREST DS CITY/TOWN Quackenkill *INSPECTOR(S)* JZS/ATA
OWNER'S NAME NYS PARKS, RECREATION & HISTORIC PRESERVATION
DOWNSTREAM HAZARD High *TOWNSHIP* Town of Grafton

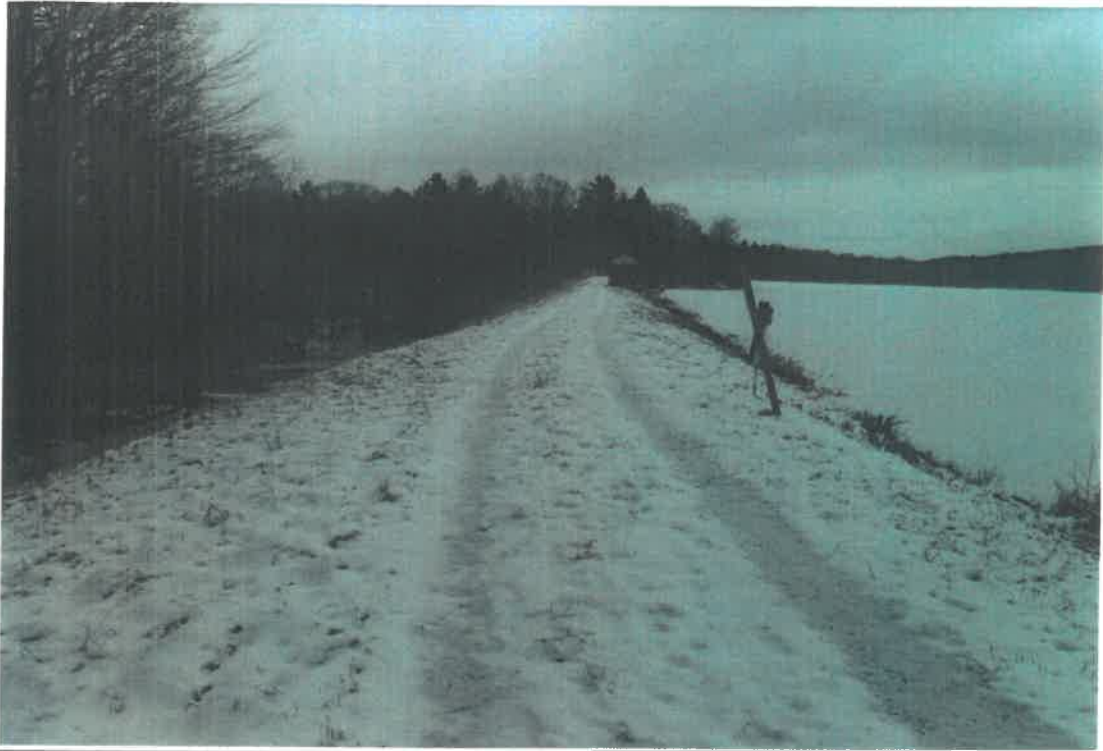
Photo 1 Dam ID# 243-1430 Martin Dunham Reservoir Dam 01/05/2024
Dam crest

- The dam crest is slightly uneven.

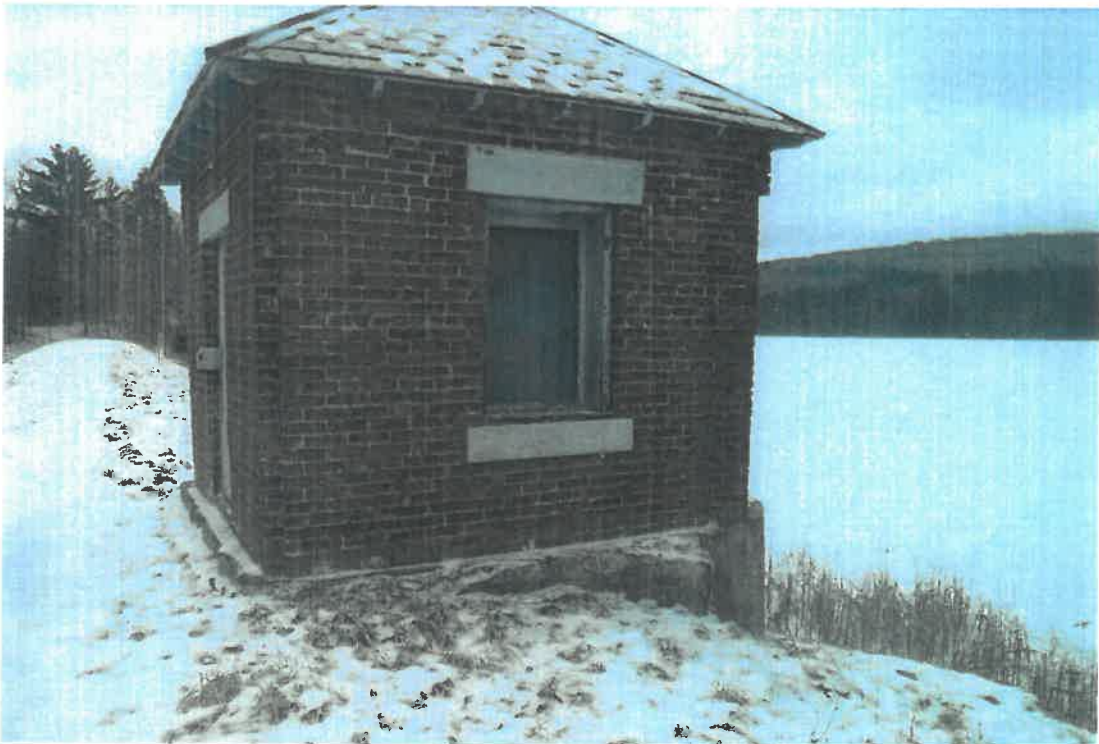
Photo 2 Dam ID# 243-1430 Martin Dunham Reservoir Dam 01/05/2024
Valve house

- Valve House: Deterioration and spalling in the concrete.
- Left low level drain (in dike): The left conduit is cracked at its end. Ponded water downstream. The flap valve for the right conduit is partially open and submerged in the water. Deterioration, spalling and vegetative growth in the concrete. Orange floc downstream on the right side.
- Right(auxiliary) low level drain: Spalling and deterioration in the concrete. The flap valve appears to be closed with orange floc around and seepage.

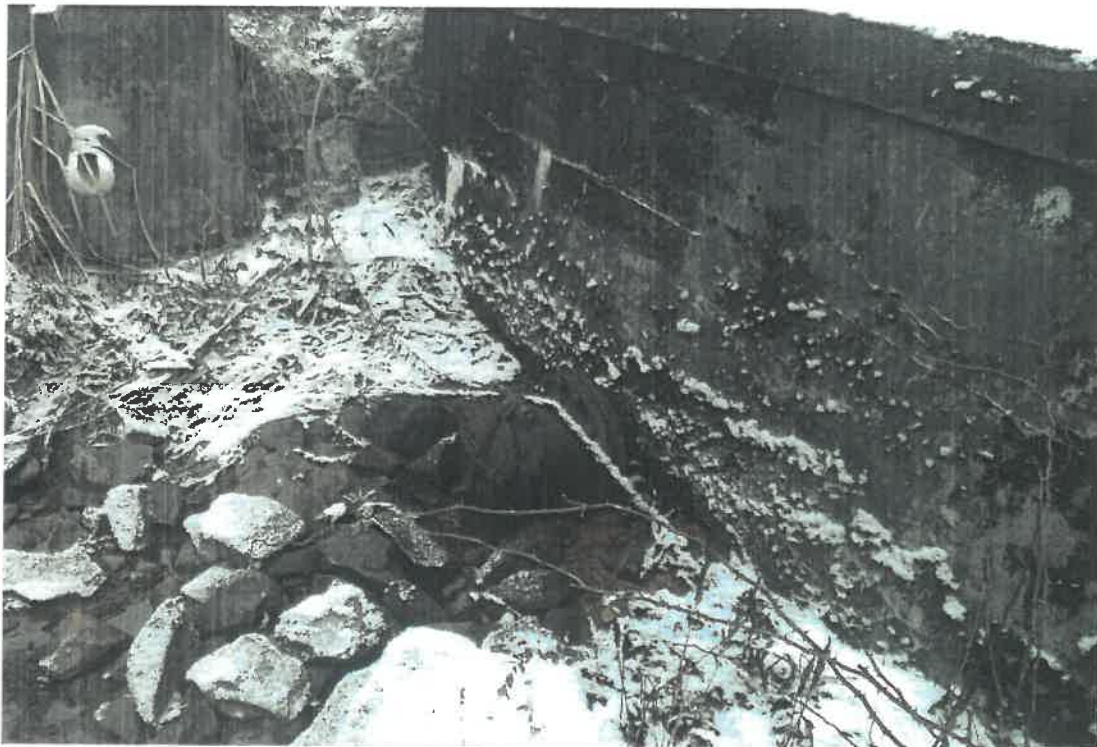
Photo 4 Dam ID# 243-1430 Martin Dunham Reservoir Dam 01/05/2024
Right (auxiliary) low level drain and toe drain

- Deterioration and cracking in the concrete walls. Large void underneath the lower step with seepage emerging from a section.
- Right embankment could not be accessed for inspection. Toe drain headwall is tilting into the downstream direction.

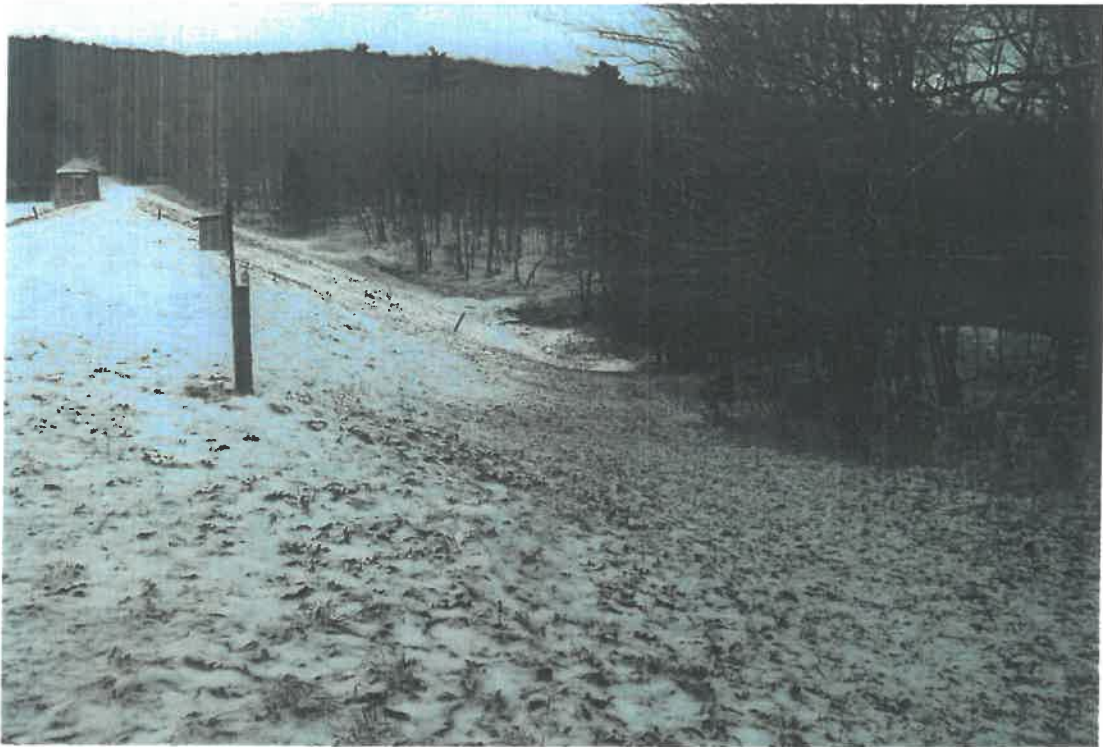
Photo 9 Dam ID# 243-1430 Martin Dunham Reservoir Dam 01/05/2024
Downstream face of the dam

- Phragmites on the right downstream toe. Sogginess on the right toe. Well mowed.
